# FY2022 CENTRAL TEXAS TURNPIKE SYSTEM ANNUAL INSPECTION REPORT

Subject: FY 2022 Inspection of the Central Texas Turnpike System

## ANNUAL INSPECTION REPORT FOR THE FISCAL YEAR ENDING AUGUST 31, 2022

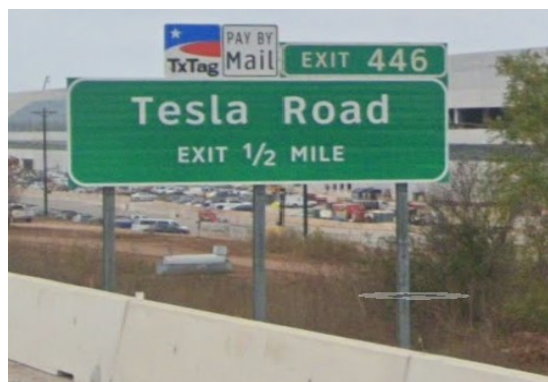
**Figure 5. Large Guide Sign on SH 130**

A Traffic Operations & Safety Appurtenance score rating of 75.4 was achieved across all roadways in the system, a decrease from 81.6 last year. The decrease in score was primarily due to striping and small signs on SH 130, SH 45N and SH 45SE. In addition, delineation on SH 130 and 45N received a lower score this year due to missing delineation and dirty reflective material, which results in decreased visibility.

In addition, a complete large guide sign inventory was performed, and both daytime and nighttime assessments were conducted. The findings for this year's inspection indicate that 52.9% of the large signs received a rating of 3 or below, with 15.2% receiving a 1 or 2 rating. The remainder of the signs received a 4 or 5 rating, which is considered Good to Excellent, respectively. The signs receiving ratings of 3 or below were rated down primarily because of degraded retro reflectivity due to age or dirt on the reflective surface.

The current roadway PBMC requires the maintenance contractor to address all Traffic Operations & Safety Appurtenances deficiencies that are considered routine. Routine deficiencies include response times that are stipulated and addressed as part of the PBMC scope. In addition, with the large guide signs approaching the end of their typical service life, TxDOT let a system-wide large sign replacement project that is currently in process, which will address many of the sign deficiencies identified during this year's inspections.

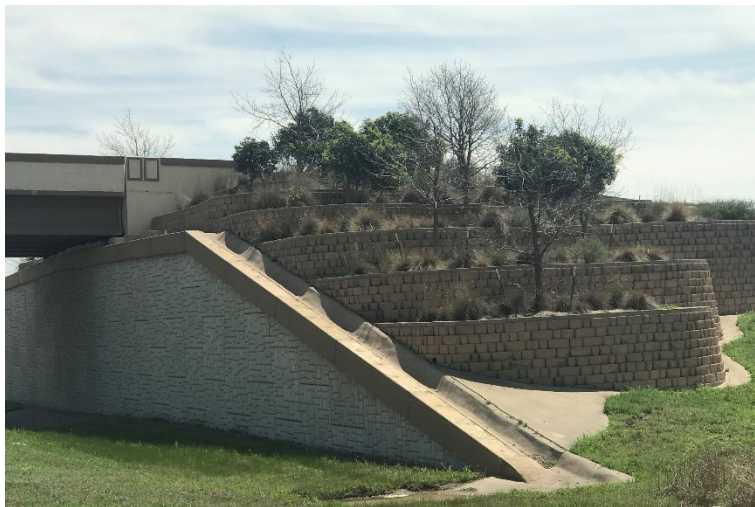
Figure 6. Roadside Conditions

The determination of the Roadside score for roadside features is generally based on the consideration of vegetation management, litter removal, drainage structures, and other elements located outside the paved travel way (Figure 6). The Roadside category achieved an overall score of 90.0, a decrease from 91.9 last year, primarily due to litter and debris observed on SL 1 and SH 45SE.

The current roadway PBMC requires the maintenance contractor to address roadside deficiencies that are considered routine. Routine deficiencies include response times that are stipulated and addressed as part of the PBMC scope.

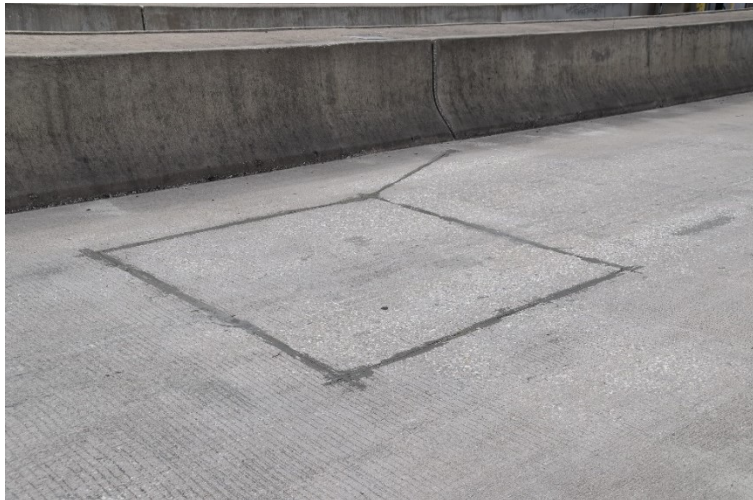
**Figure 7. Toll System Pavement Showing IVIS**

In 2015, as a result of numerous loop sensor failures on CTTS facilities and per TOD request, Atkins conducted a study to investigate the potential causes of the failures. These in-pavement loop sensors (Figure 7), which are part of the IVIS, detect and classify vehicles traveling through the toll zone. The study found that multiple issues could be attributed to the failures, including damage to the loop sensor wire, improper loop sensor installation, and pavement cracking in the vicinity of the sensors. While pavement cracks were found to be one of the potential causes, the study did not show a direct relationship between the presence of pavement cracks and loop sensor failures. Furthermore, a life-cycle cost analysis determined that it is more economical for TOD to continue to replace loop sensors that fail until the toll zone pavement requires complete replacement. TxDOT continuously monitors these locations and performs supplementary inspections and maintenance to ensure that the toll system's collection capabilities are not affected. From FY 2017 through FY 2021, loop sensors were replaced at 15 locations.
