# SH 249 System Annual Inspection Report

September 1, 2021 thru August 31, 2022

RE: SH 249 FY 2022 System Annual Inspection Report

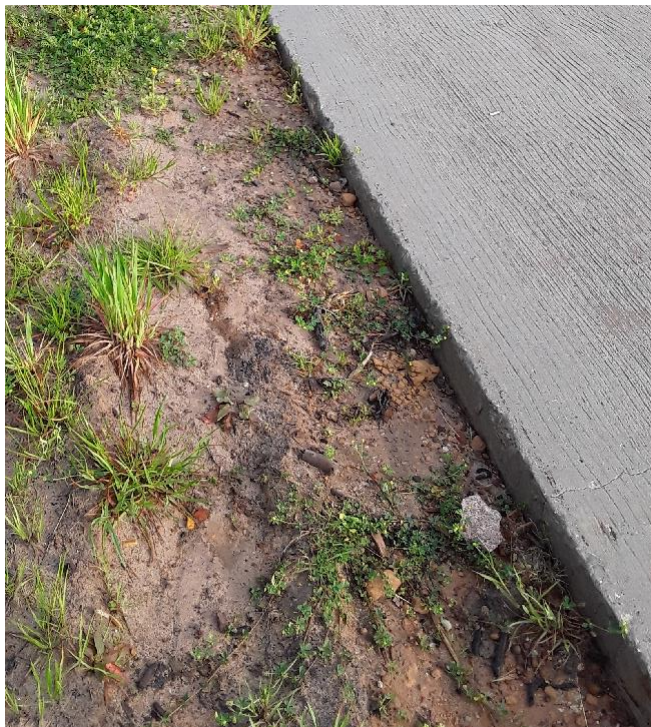
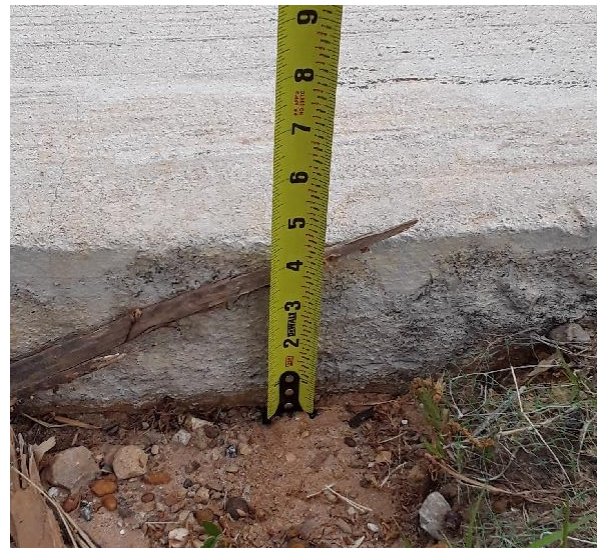
condition. The roadway inspection identified several deficiencies of edge drop offs and damaged cable barrier/metal beam guard fence. These deficiencies were reported to the DB Contractor and TxDOT Area Office for repair and are delineated with traffic cones for safety. The roadway inspection additionally identified a dip in the pavement along the northbound mainlanes south of the Future Terra bridge that will require renewal work to correct.

### Edge Drop-Off

Recommendation 1: Edge Drop Off – the inspection identified areas of edge drop off from 3-inches to 5-inches due to erosion. The GEC recommends that DB Contractor continue to perform slope repair remedies using block sod or soil with a high organic material content that will both resist erosion and promote dense vegetative cover.

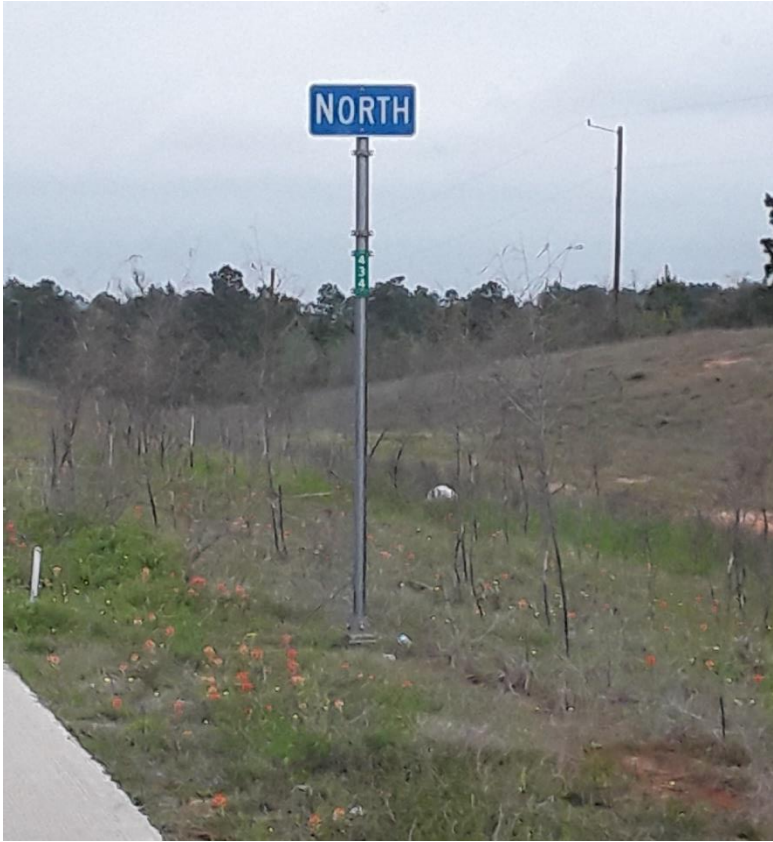
Inspection of the roadside elements consisted of the general condition of: large guide signs and small roadside signs for damage, retro-reflectivity and wear; noise walls for damage; illumination for damaged poles; the ITS system for damaged poles or cabinets; and establishment and management of ground cover. The SH 249 System is a new facility and the roadside elements remain in excellent condition. Two deficiencies were identified with both issues relating to signs.

#### Missing SH 249 Trailblazer Sign

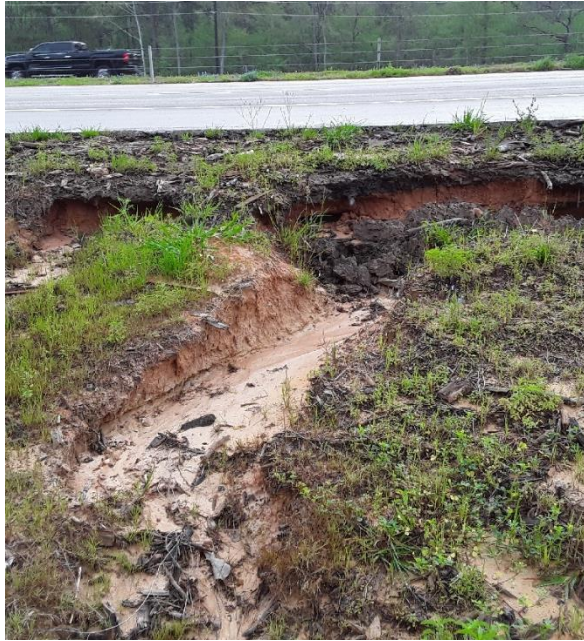
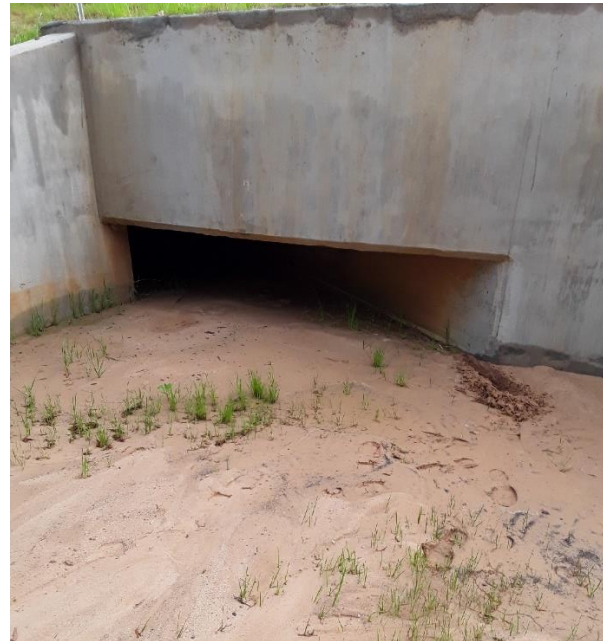
Inspection of the embankment elements consisted of the general condition of the side slopes to ensure no erosion or slope failure; drainage ditches for debris and ponding; drainage culverts for siltation and/or debris blockage; and inlets to ensure that they are operating as intended. The SH 249 System is a new facility and the embankment elements are in good condition. Nineteen embankment deficiencies were identified with the majority being issues with side slope erosion due to the sandy topsoil used for final grade and the on-going establishment of vegetative cover.

### Embankment Failure and Siltation at Culvert

Recommendation 3: Erosion Repair – many areas along the SH 249 corridor have experienced slope and ditch erosion mostly due to balding patches of vegetation cover which is causing downstream siltation, undercutting, and slope failure. The GEC recommends that DB Contractor continue to

perform slope repair remedies, including the reestablishment of ditch flowlines, using block sod or backfill soil with a high organic material content that will both resist erosion and promote dense vegetative cover.

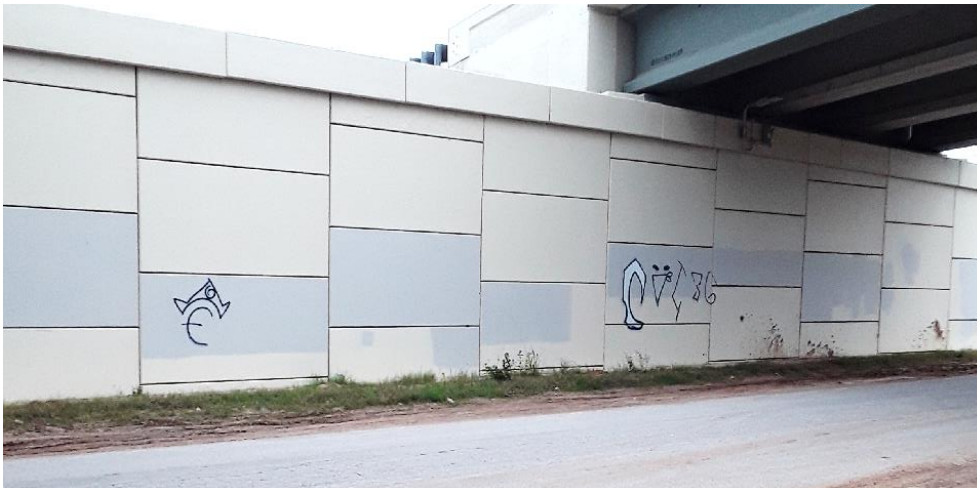
Inspection of the structures consisted of the general condition of the bridges and retaining walls for damage and wear. The SH 249 System is a new facility and the structural elements remain in excellent condition. One deficiency was identified as reoccurring graffiti on retaining walls.

#### Section 1A: Bridge BR1A-04 Abutment Wall with Reoccurring Graffiti

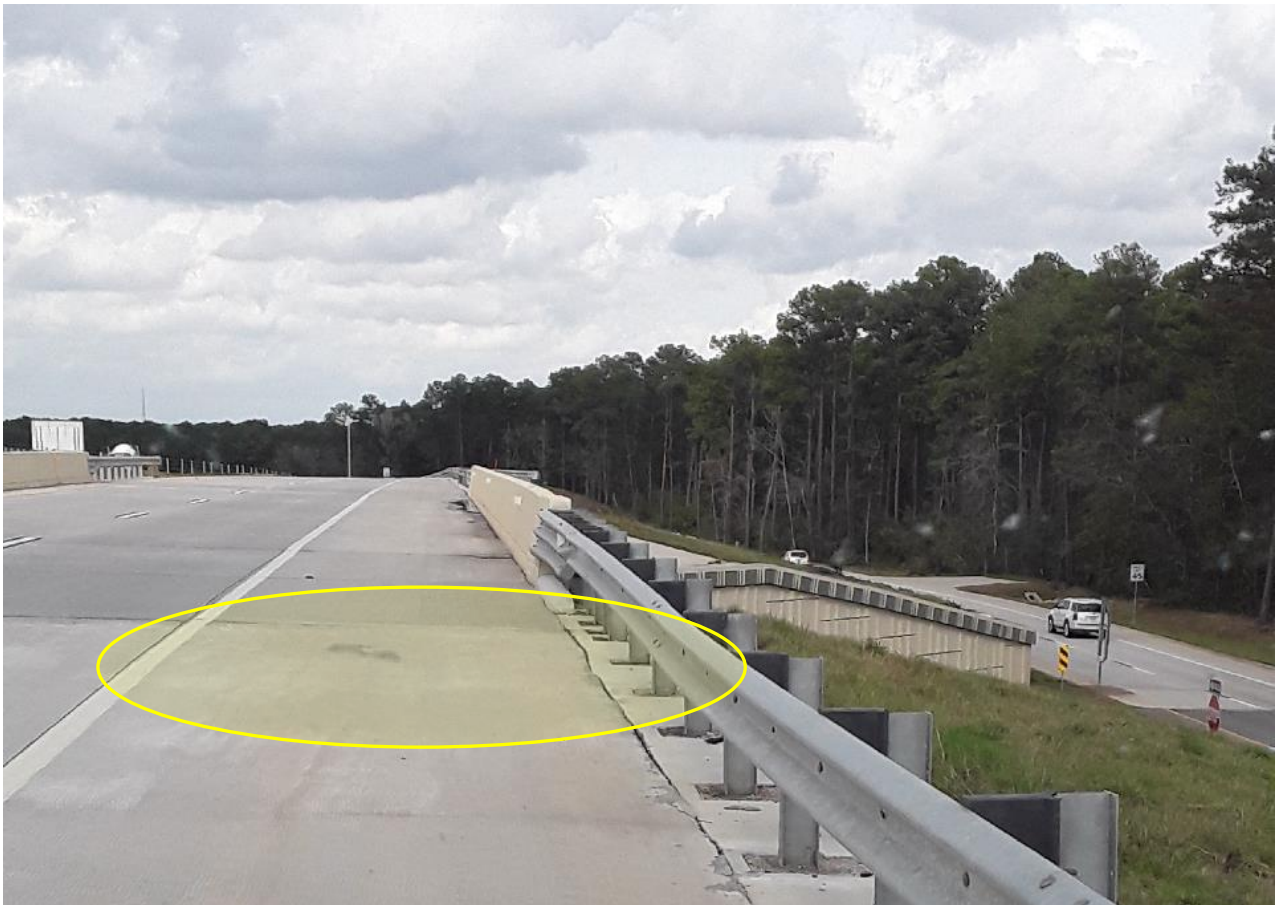
#### Section 1A Pavement Dip South of Future Terra Northbound Bridge

Recommendation 2: Dip in Pavement – The inspection noted a settlement in the outside lane of the northbound mainlane pavement just south of the Future Terra Bridge. The GEC recommends that DB Contractor perform renewal work to correct the pavement using a deep Injection process of expansive polyurethane material to stabilize the soil under the roadway and create lift to restore the pavement to the original grade.
