# SH 249 System Annual Inspection Report

September 1, 2020 thru August 31, 2021

RE: SH 249 FY 2021 System Annual Inspection Report

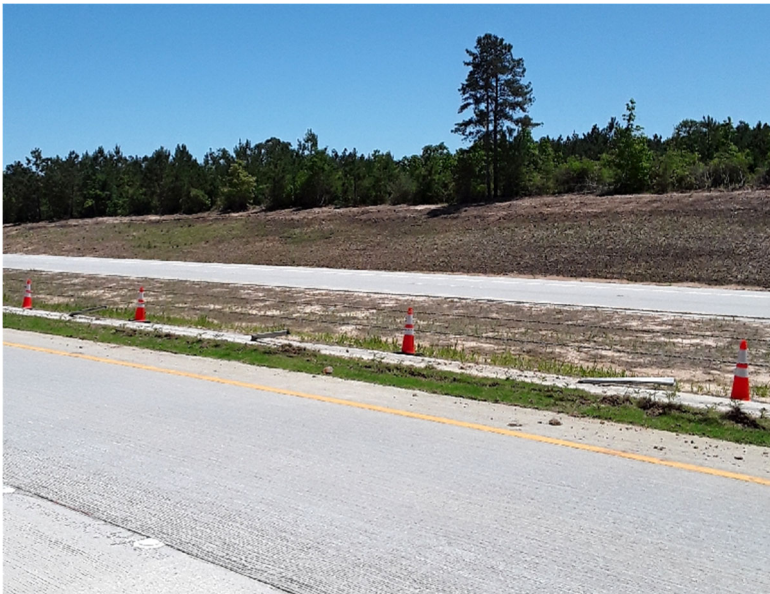
elements. The SH 249 System is a new facility and the roadway elements remain in excellent condition. The roadway inspection identified several deficiencies of damaged cable barrier/MBGF. These deficiencies were reported to the TxDOT Area Office for repair and are currently delineated with traffic cones for safety. The roadway inspection also identified areas along the Section 1B mainlane pavement at construction entrances/exits that were in need sweeping and locations on the shoulder that had minor pavement spalls.

#### Section 1A Damaged Cable Barrier south of FM 1774

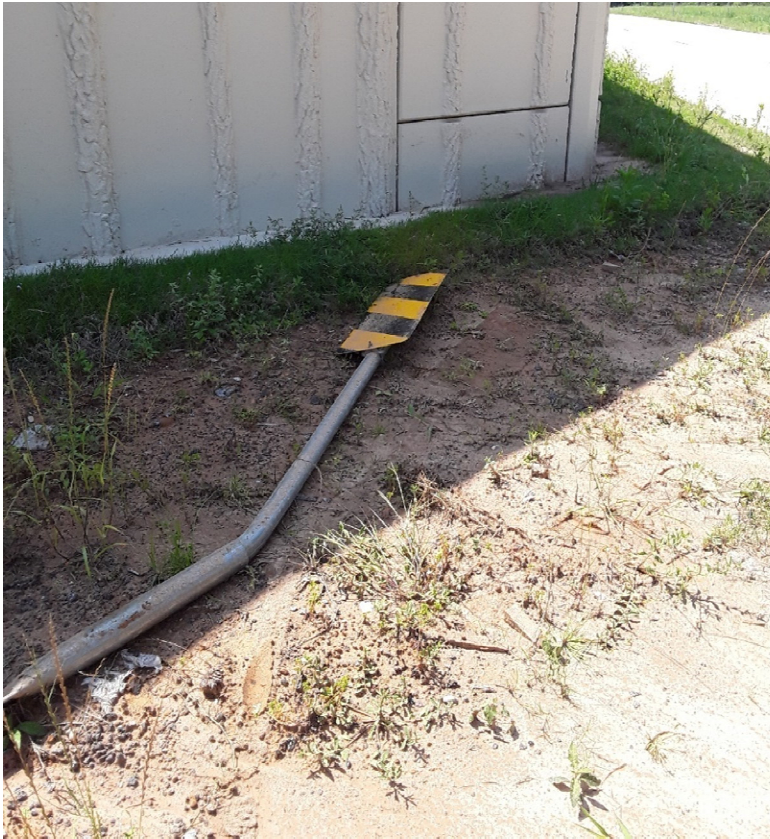
Inspection of the roadside elements consisted of the general condition of: the large guide signs and small roadside signs for damage, retro-reflectivity and wear; noise walls for damage; illumination for damaged poles; the ITS system for damaged poles or cabinets; and establishment and management of ground cover. The SH 249 System is a new facility and the roadside elements remain in excellent condition. Twenty-two deficiencies were identified with the majority being areas that need mowing, areas that need established vegetation (seeding), and small signs deficiencies.

### Section 1A FM 149 Object Marker Small Sign Damage

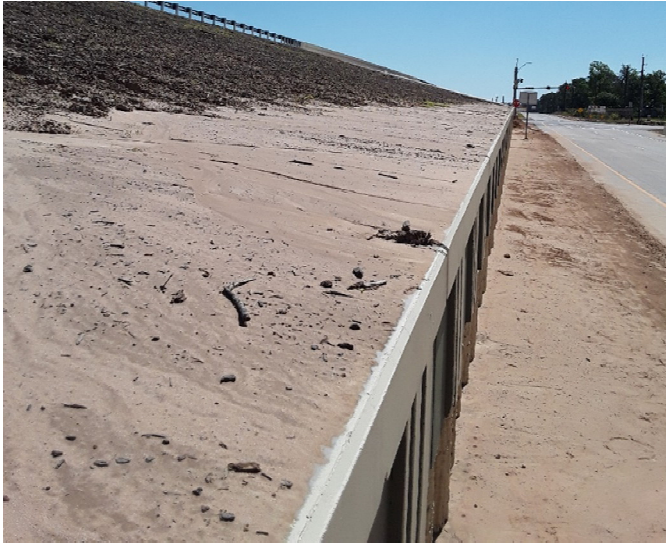
Inspection of the embankment elements consisted of the general condition of: the side slopes to ensure no erosion or slope failure; drainage ditches for debris and ponding; drainage culverts for siltation and/or debris blockage; and inlets to ensure that they are operating as intended. The SH 249 System is a new facility and the embankment elements are in good condition. Ninety-one deficiencies were identified with the majority being issues with side slope erosion, culvert siltation, cleaning and repairing SWPPP devices, and ditch ponding. The majority of these deficiencies are located in Section 1B and were included on the punch list for corrective action prior to Final Acceptance of the Work and are dependent on establishing proper vegetative cover.

### Section 1B FM 1486 Retaining Wall Embankment Erosion and Flume Silting

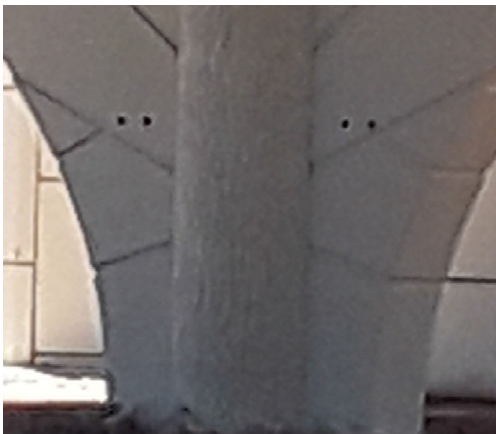
Inspection of the structures consisted of the general condition of the bridges and retaining walls for damage and wear. The SH 249 System is a new facility and the structural elements remain in excellent condition. Twenty-six deficiencies were identified with the majority located in Section 1B concerning general cleanup around and under the structures, patching the column bolt holes used for erection, patching the retaining wall coping, cleaning the flume, and sub-structure painting.

### Section 1B FM 1486 Bridge Column with Unpatched Bolt Holes

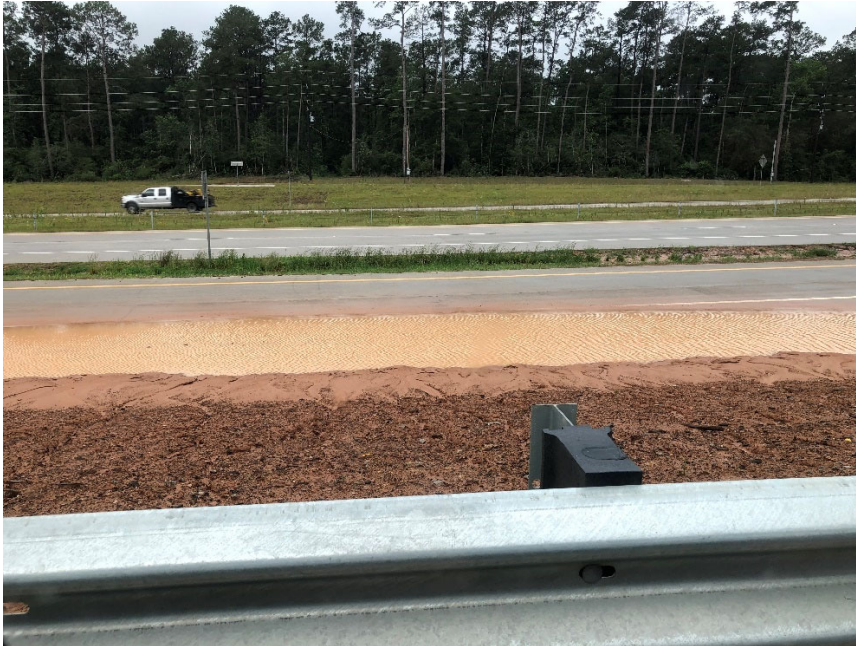
Recommendation 1: Elimination of water on Roadways – the inspection identified water ponding on the shoulders and mainlanes that is either overflowing from drainage ditches or seeping from the embankments and retaining walls adjacent to the roadways. This water and the underlying causes for the ponding must be eliminated for safety purposes as well as to prevent deterioration of the embankment and pavement. These deficiencies are located within Section 1B and were

#### Section 1B Ramp E Ponding

added to the punch list for Final Acceptance. The DB Contractor was notified to determine the cause of water seepage that flows onto the mainlanes at Ramps E, J, and L and prepare plans and specifications to repair.

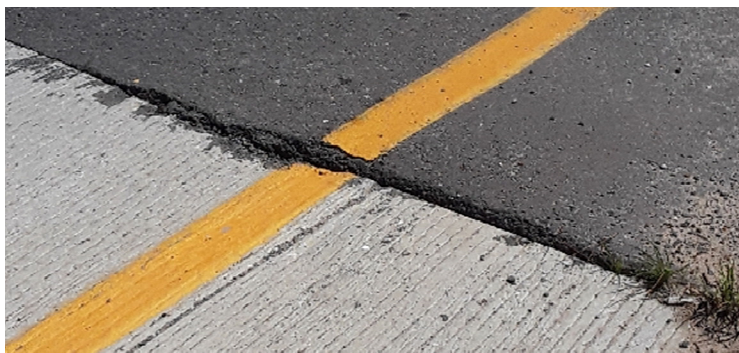
#### Section 1A Joint Wear at Future Terra Blvd.

Recommendation 2: Joint and Crack Sealing – The inspection noted joint wear along the northbound frontage road at Future Terra Blvd at the asphalt and concrete pavement interface. The GEC recommends that joint and crack sealing is performed on a yearly basis to repair new and existing cracks and joints as needed to maximize performance of the pavement.

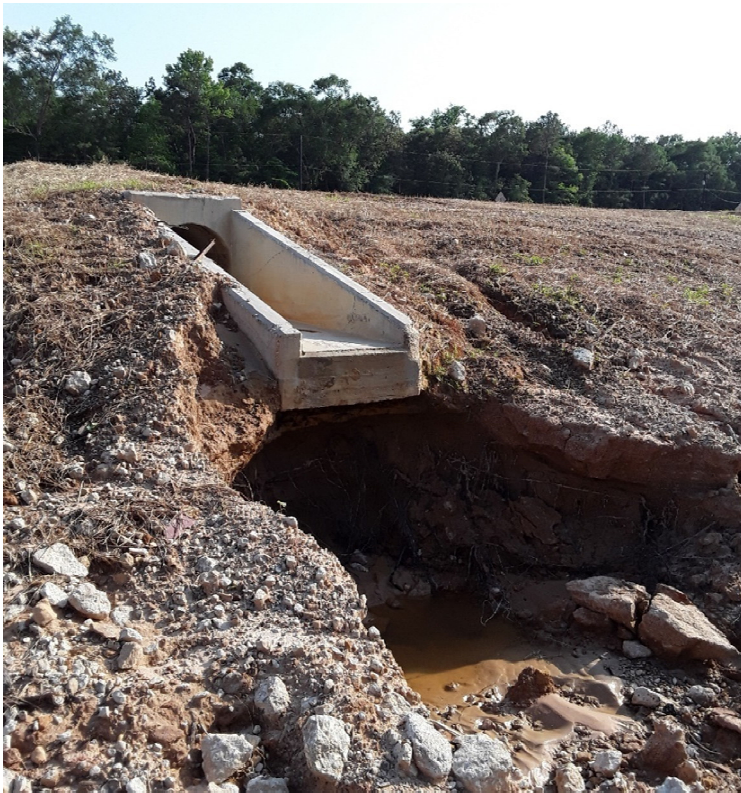
### Section 1B Erosion and Washout at Safety End Treatment

Recommendation 3: Erosion Repair – many areas along the SH 249 corridor have experienced shoulder or slope erosion causing rivulets and siltation in the drainage system. Several factors such as lack of vegetation growth, bridge drains without splash protection and large vehicles overshooting their wheel path are contributing to the erosion problems at the interchange. The GEC recommends that DB Contractor continue to provide and maintain silt fence and perform slope repair remedies; however, a permanent fix will not be feasible until the vegetative cover is fully established.
