# FY2021 CENTRAL TEXAS TURNPIKE SYSTEM ANNUAL INSPECTION REPORT

Subject: FY 2021 Inspection of the Central Texas Turnpike System

## ANNUAL INSPECTION REPORT FOR THE FISCAL YEAR ENDING AUGUST 31, 2021

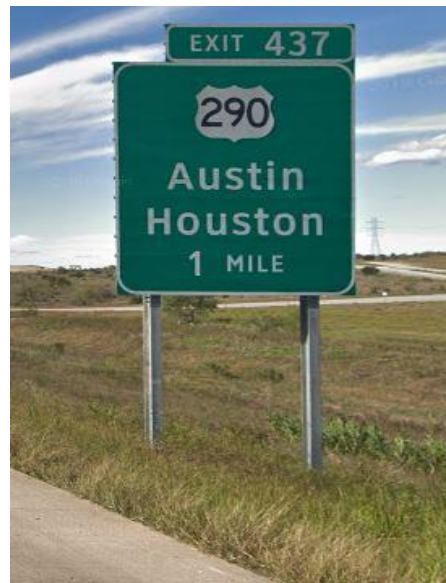
**Figure 5: Large Guide Sign on SH 130**

A Traffic Operations & Safety Appurtenance score rating of 81.6 was achieved across all roadways in the system, a decrease from 84.0 last year. The decrease in score was primarily due to striping and small signs on SH 130, SH 45SE and SH 45N that have reached the end of their service life. In addition, the lowest Traffic Operations & Safety Appurtenances element score was small signs, which received a score of 72.3 and was noted on SH 130.

The current roadway PBMC requires the maintenance contractor to address all traffic operations & safety appurtenances deficiencies that are considered routine. Routine deficiencies include response times that are stipulated and addressed as part of the PBMC scope. In addition, with the large guide signs approaching the end of their typical service life, TxDOT let a system-wide large sign replacement project that is currently in process, which will address many of the sign deficiencies that were identified during this year's inspections.

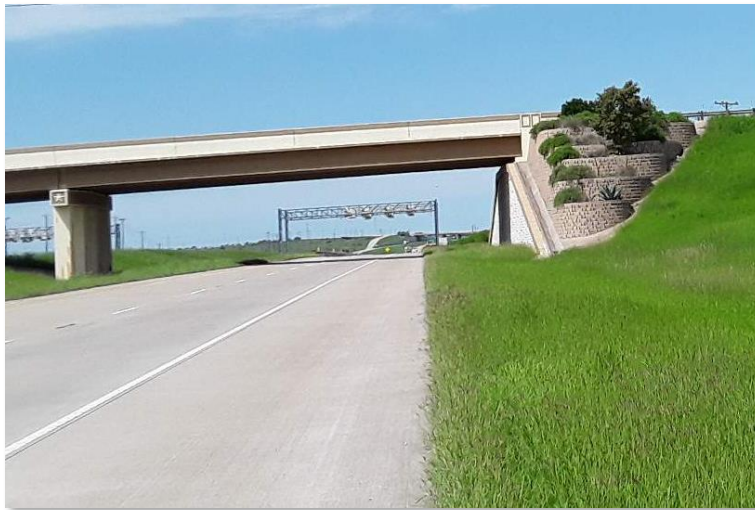
**Figure 6: Roadside Conditions**

The determination of the Roadside score for roadside features is generally based on the consideration of vegetation management, litter removal, drainage structures, and other elements located outside the paved travel way (Figure 6). The Roadside category achieved an overall score of 91.9, a decrease from 93.0 last year. The decrease in score was primarily due to vegetation management on SH 130 and SH 45SE.

The current roadway PBMC requires the maintenance contractor to address roadside deficiencies that are considered routine. Routine deficiencies include response times that are stipulated and addressed as part of the PBMC scope. In addition, it is anticipated that the pavement upgrade projects, as well as the SH 130 expansion projects mentioned in subsection 2.2.1, will address some of the roadside deficiencies that were found.

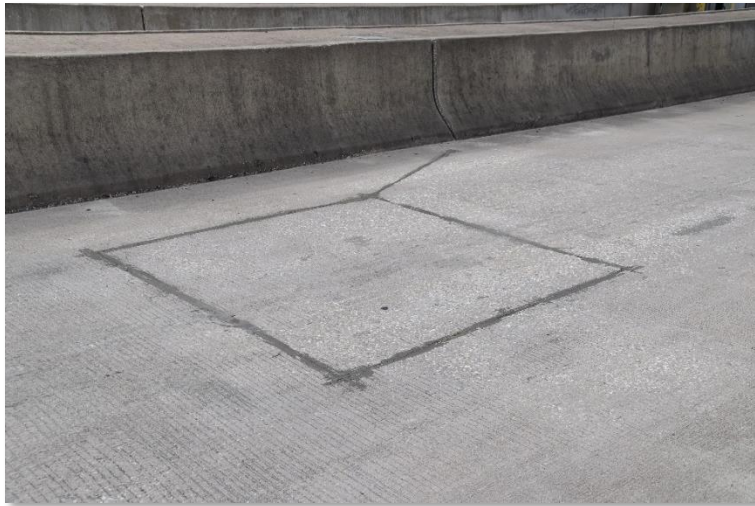
**Figure 7: Toll System Pavement Showing IVIS**

In 2015, as a result of numerous loop sensor failures on CTTS facilities, per TOD request, Atkins conducted a study to investigate the potential causes of the failures. These in-pavement loop sensors, shown on Figure 7, are part of the IVIS system, which detect and classify vehicles traveling through the toll zone. The study found that multiple issues could be attributed to the failures, including damage to the loop sensor wire, improper loop sensor installation, and pavement cracking in the vicinity of the sensors. While pavement cracks were found to be one of the potential causes, the study did not show a direct relationship between the presence of pavement cracks and loop sensor failures. Furthermore, a life-cycle cost analysis determined that it is more economical for TOD to continue to replace loop sensors that fail until the toll zone pavement requires complete replacement. TxDOT continuously monitors these locations and performs supplementary inspections and maintenance to ensure that the toll system's collection capabilities are not affected. From FY 2017 through FY 2019 ten locations were replaced, in FY 2020 one location was replaced.
