## SH 249 System

## Annual Inspection Report

September 1, 2022 through August 31, 2023

RE: SH 249 FY 2023 System Annual Inspection Report

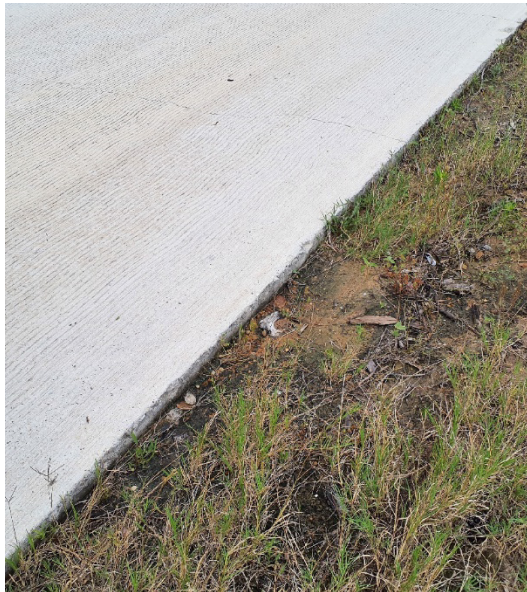
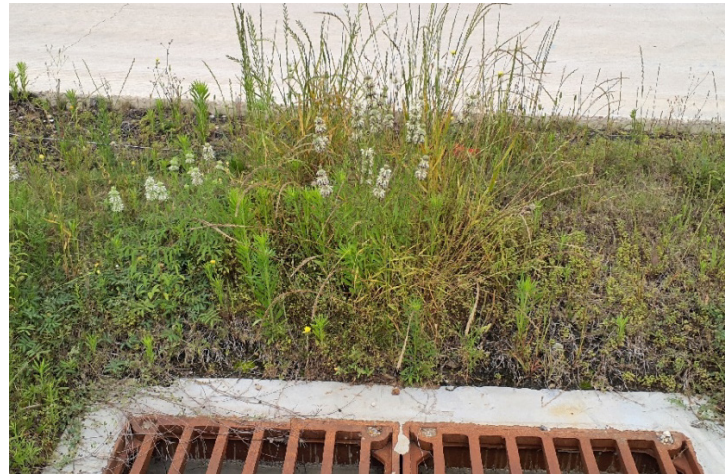
#### Edge Drop-Off

for missing marker/buttons and wear; and the rigid and flexible barrier for damage or missing reflectors. The SH 249 System is a new facility and the roadway elements remain in excellent condition. The roadway inspection identified multiple deficiencies of edge drop offs and two areas of damaged cable barrier/metal beam guard fence. These deficiencies were reported to the DB Contractor and TxDOT Area Office for repair and are delineated with traffic cones for safety.

Recommendation 1: Edge Drop Off – the inspection identified areas of edge drop off from 3-inches to 5-inches due to erosion. The GEC recommends that DB Contractor continue to perform slope repair remedies using block sod or soil with a high organic material content that will both resist erosion and promote dense vegetative cover.

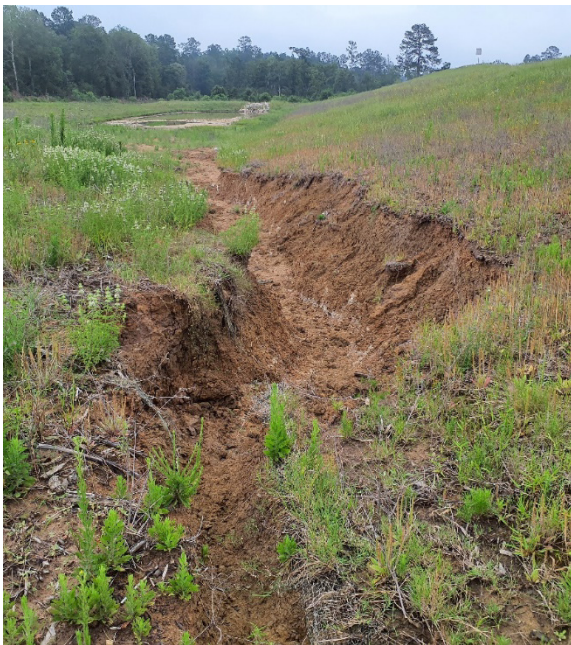
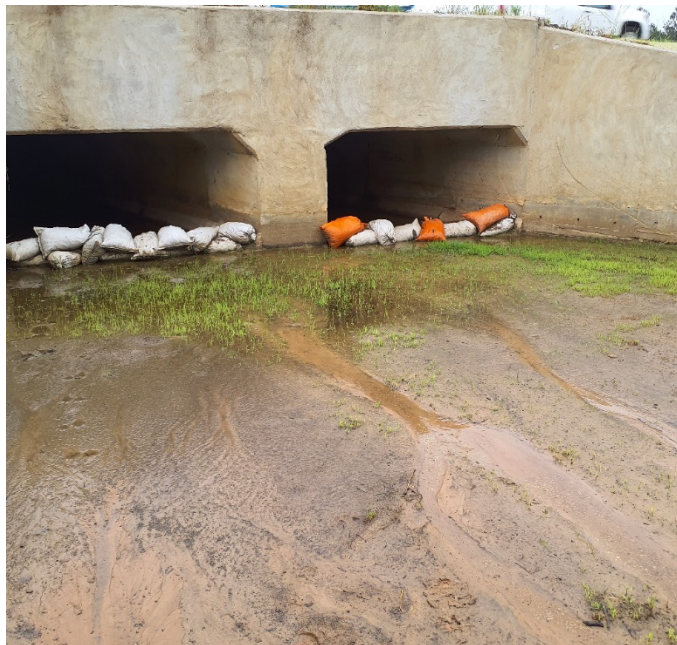
### Embankment Failure and Siltation at Culvert

The embankment system elements are inspected monthly with biennial inspections conducted specifically for the drainage system. Visual inspection of the embankments was performed with the majority of issues relating to side slope erosion which is causing deep rivulets and sediment transport and buildup at the drainage culverts. This is an on-going issue which the DB Contractor is addressing.

Inspection of the embankment elements consisted of the general condition of the side slopes to ensure no erosion or slope failure; drainage ditches for debris and ponding; drainage culverts for siltation and/or debris blockage; and inlets to ensure that they are operating as intended. The SH 249 System is a new facility and the embankment elements are in good condition. Five embankment deficiencies were identified with the majority of issues relating to side slope erosion which is causing deep rivulets and sediment transport and buildup at the drainage culverts.

Recommendation 2: Erosion Repair – The GEC recommends that DB Contractor continue to perform slope repair remedies, including siltation removal.
