# FY2023 CENTRAL TEXAS TURNPIKE SYSTEM ANNUAL INSPECTION REPORT

Subject: FY 2023 Inspection of the Central Texas Turnpike System (CTTS)

## ANNUAL INSPECTION REPORT FOR THE FISCAL YEAR ENDING AUGUST 31, 2023

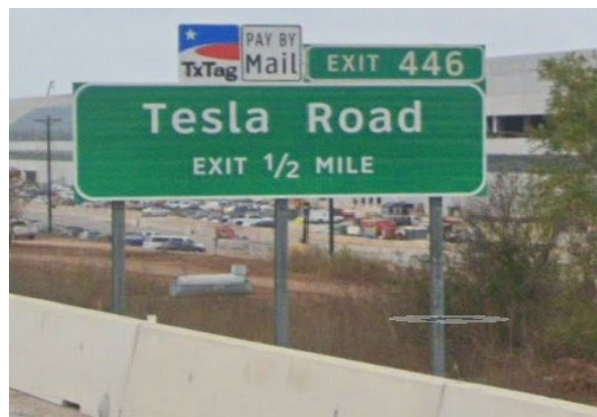
**Figure 5. Large Guide Sign on SH 130**

In addition, a complete large guide sign inventory was performed, and both daytime and nighttime assessments were conducted. The findings for this year's inspection indicate that 27.6% of the large signs received a rating of 3 or below, with 12.8% receiving a 1 or 2 rating. The remainder of the signs received a 4 or 5 rating, which is considered Good to Excellent, respectively. The signs receiving ratings of 3 or below were rated down primarily because of degraded retro reflectivity due to age or dirt on the reflective surface.

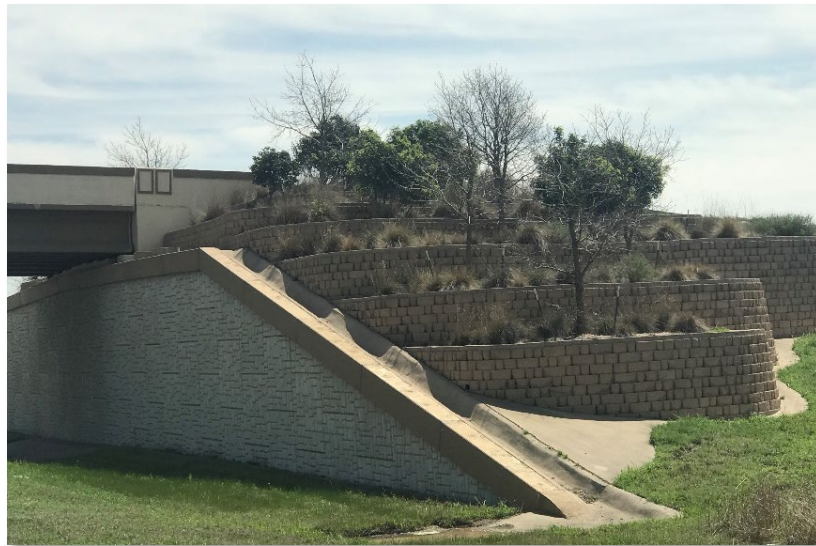
**Figure 6. Roadside Conditions**

The determination of the Roadside score for roadside features depends on vegetation management, litter removal, drainage structures, and other elements located outside the paved travel way (Figure 6). The Roadside category achieved an overall score of 85.0, a decrease from 90.0 last year, primarily due to the presence of litter and debris on SL 1, SH 130, and SH 45SE; trees and brush encroaching the pavement and under bridges on SH 45N, SH 130, and SH 45SE; and drainage structures blocked with silt and vegetation on SH 130 and SH 45SE.

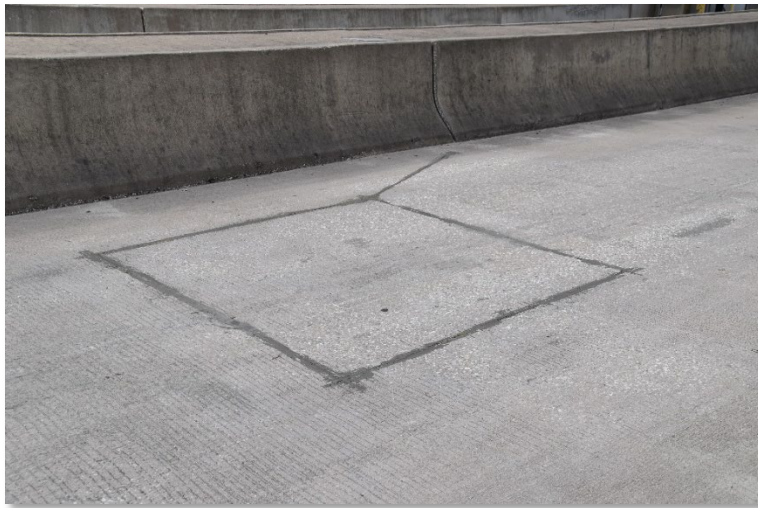
**Figure 7. Toll System Pavement Showing IVIS**

In 2015, as a result of numerous loop sensor failures on CTTS facilities and per TxDOT's request, Atkins conducted a study to investigate the potential causes of the failures. These in-pavement loop sensors (Figure 7), which are part of the IVIS, detect and classify vehicles traveling through the toll zone. The study found that multiple issues could be attributed to the failures, including damage to the loop sensor wire, improper loop sensor installation, and pavement cracking in the vicinity of the sensors. While pavement cracks were found to be one of the potential causes, the study did not show a direct relationship between the presence of pavement cracks and loop sensor failures. Furthermore, a life-cycle cost analysis determined that it is more economical for TxDOT to continue replacing failed loop sensors until the toll zone pavement requires complete replacement. TxDOT continuously monitors these locations and performs supplementary inspections and maintenance to ensure that the toll system's collection capabilities are not affected. From FY 2017 through FY 2022, loop sensors were replaced at 18 locations.

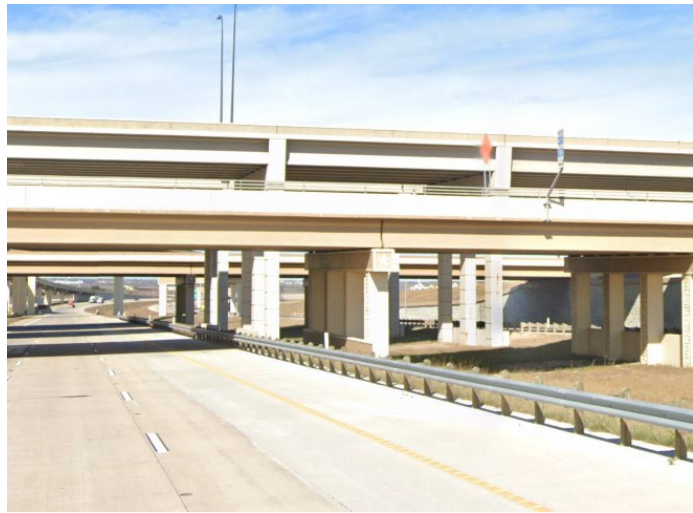
**Figure 11. SH 130 at US 290 Bridge**

TxDOT inspects all bridges within the CTTS biennially. Findings from the previous inspection cycle (FY 2022) indicate that 84.1% of the components were rated Good to Excellent. A total of 1,002 components in the categories used to evaluate bridge load ratings were inspected on the 242 structures within the CTTS. Only 159 components (15.9%) had a rating as low as 6 or less, with the remainder of the ratings falling within the 7 to 9 range (Good to Excellent). The components that received a 6 or less rating had issues such as riprap settlement, metal beam guard fence damage, joint seal degradation, clogged deck drains, missing delineation, and approach slab settlement.

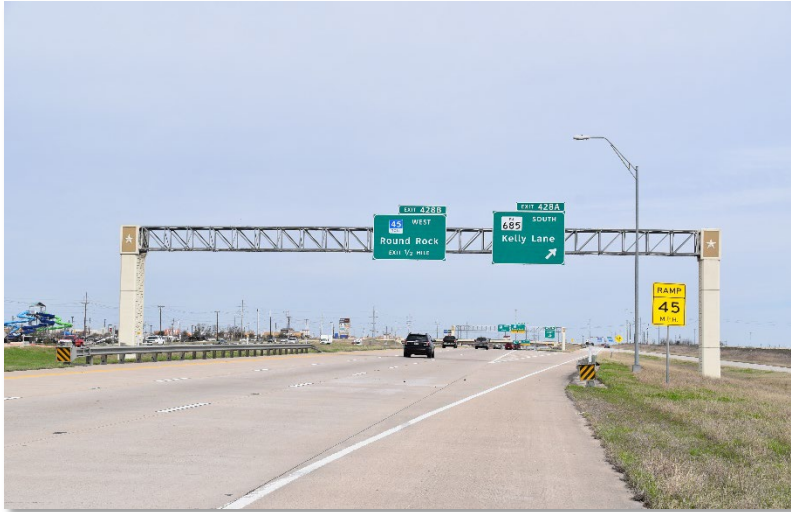
**Figure 12. Overhead Sign Structure**

Beginning in FY 2011, inspections for overhead and cantilever sign structures were conducted biennially, with SH 130 and SL 1 inspections conducted in one year, and SH 45N and SH 45SE conducted in the alternate year. During this year's inspection, the overhead and cantilever sign structures on SH 45N and SH 45SE were inspected, totaling 108 structures.

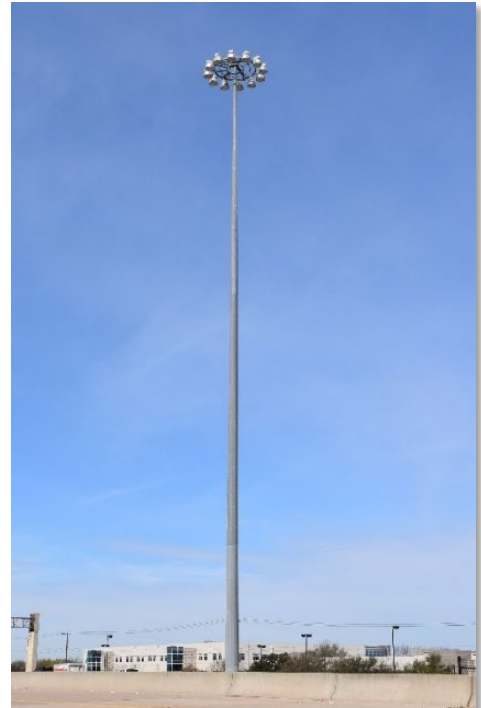
**Figure 13. High-Mast Light Tower**

Beginning in FY 2011, the HMLTs inspection occurred biennially with inspections being alternated on two roadways per year. During this year's inspection, SH 45N and SH 45SE were inspected, which consists of 90 structures. The results indicate that 99.3% of the 22,466 components were rated Satisfactory to Good, which is a 0.1% decline from the SH 45N and SH 45SE inspection conducted in FY 2021.

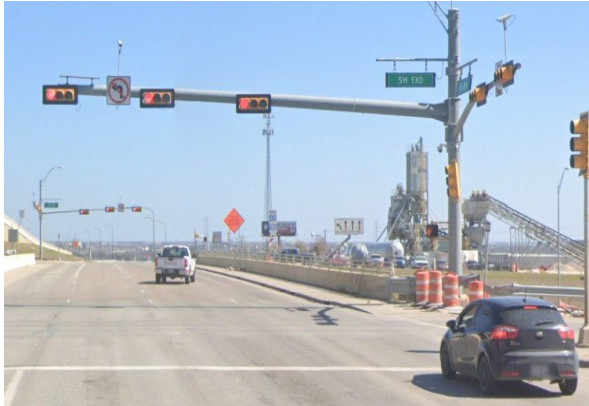
**Figure 14. Traffic Signal**

1) traffic signal foundation; and 2) signal poles, including assessment of anchor bolts, base plates, column support, arm, chord and cable connections and members, attachments and luminaries. As with HMLTs, these structures are not as complex as most bridge structures, so the 10-point bridge inspection rating scale is not used, as shown in Table 20. Instead, the FHWA Elements Based rating scale, shown previously in Table 21 for overhead sign structures, is used. This rates every individual element on a 5-point rating scale. It is similar to numerical rating scales used around the country for similar-type structural elements. Beginning in FY 2020, inspections for traffic signals were conducted biennially, with SH 130 and SL 1 inspections conducted in one year, and SH 45N and SH 45SE conducted in the alternate year. During this year's inspection, SH 45N and SH 45SE were inspected, which consists of 33 traffic signals. The results indicate that 98.1% of the 692 components were rated Satisfactory to Good. This percentage is identical to the SH 45N and SH 45SE inspection that was conducted in FY 2021.
