\$198,940,000

CITY OF SYRACUSE INDUSTRIAL DEVELOPMENT AGENCY
Tax-Exempt Refunding PILOT Revenue Bonds, Series 2016A
(Carousel Center Project)

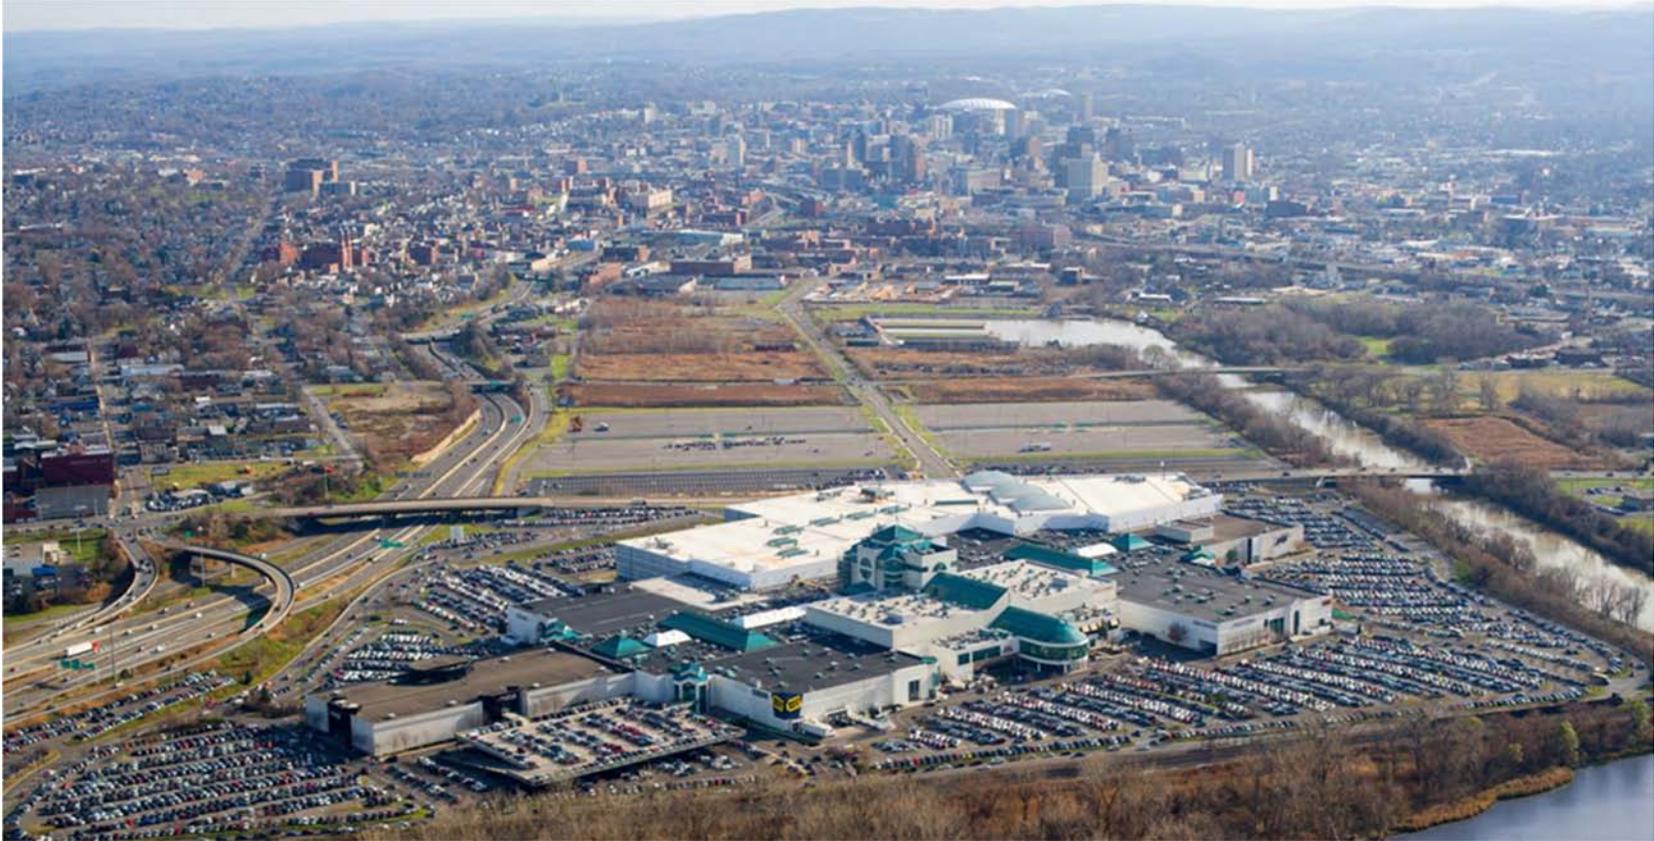
Photo of Destiny USA. The Carousel Center is the multi-level structure in the foreground of the photo. The Expansion Project is the primarily white structure immediately to the rear of the Carousel Center in the photo.

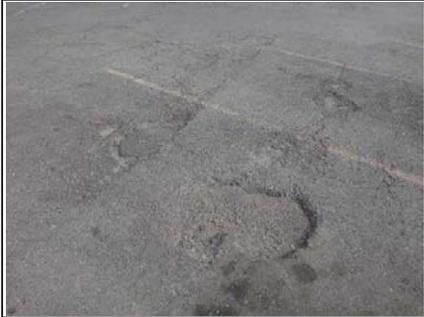
8. Potholes and deteriorating parking area asphalt paving.

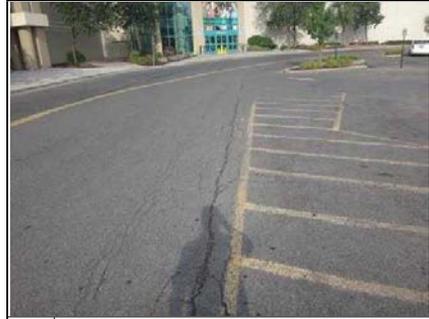
9. Cracked and alligatored pavement.

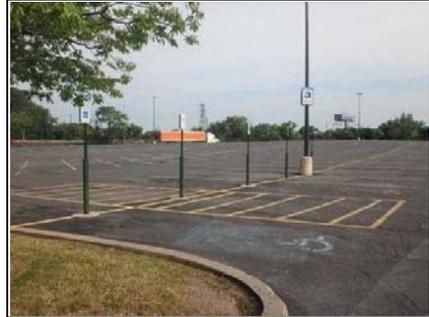
10. HC parking, no van signs installed.

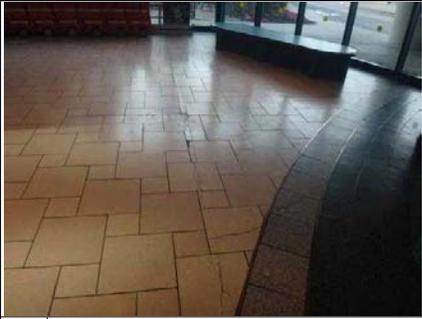
15. Minor slab cracks at mall entry.

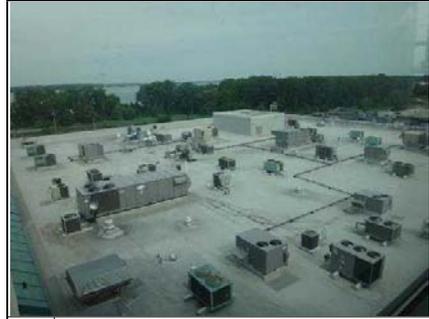
17. Recently replaced roof area.

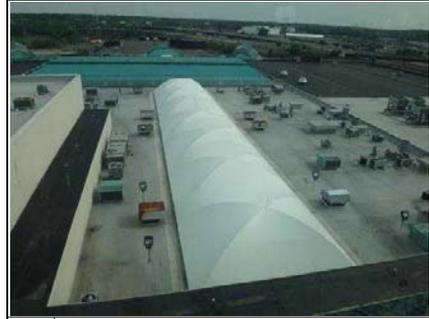
18. Teflon-coated fiberglass fabric roof area.

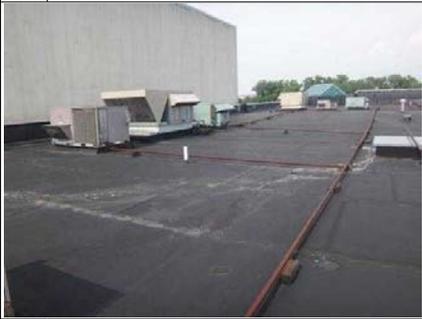
20. Older EPDM roof area, slated for 2016 replacement.

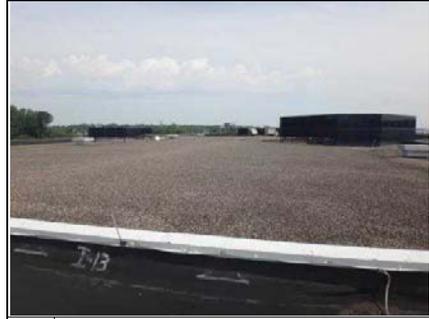
21. Ballasted EPDM roof over Macy's store.
