# FY2021 CENTRAL TEXAS TURNPIKE SYSTEM ANNUAL INSPECTION REPORT

Subject: FY 2021 Inspection of the Central Texas Turnpike System

## ANNUAL INSPECTION REPORT FOR THE FISCAL YEAR ENDING AUGUST 31, 2021

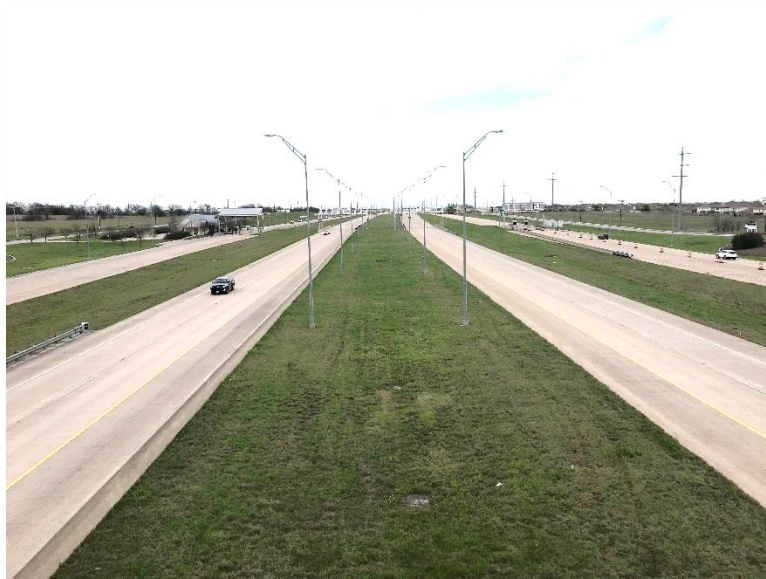
**Figure 4: Typical Roadway Pavement Section**

The Pavement category includes rutting, cracking, pavement failures, ride rating, and edges. Figure 4 illustrates a typical roadway pavement section on the system. Pavement throughout the CTTS achieved an overall score of 85.4, which is a decrease from last year's score of 87.9. The decrease in score was primarily due to increased pavement cracking on SH 130 and SL1, as well as increased edge drop-offs on SL1, SH 130 and SH 45SE. Because of the extensive presence of sulfates in the area of SH 130 and SH 45SE, the soils have a tendency to expand and contract. In addition, portions of SL1 fall within the mapped outcropping of the Del Rio clay, which is known for its expansive characteristics with changes in moisture content. Over the past few years, there has been significant seasonal rainfall, which could cause movement in the soil subgrade and the pavement structure, leading to increased surface defects.

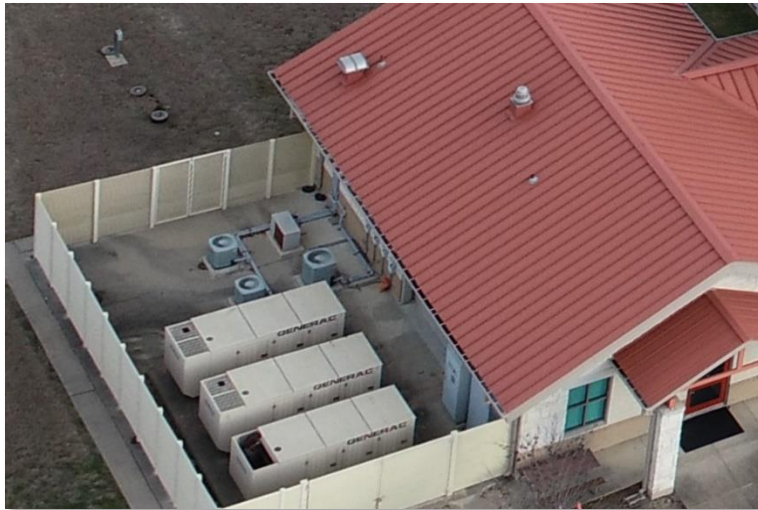
**Figure 10: Facility Generators**

Electrical elements include building electrical features, wiring, UPS, traffic signals, roadside cabinets, and generators (see Figure 10). Of the 1,065 total elements inspected in the electrical category, only 4 elements received a score lower than a three (3) rating.

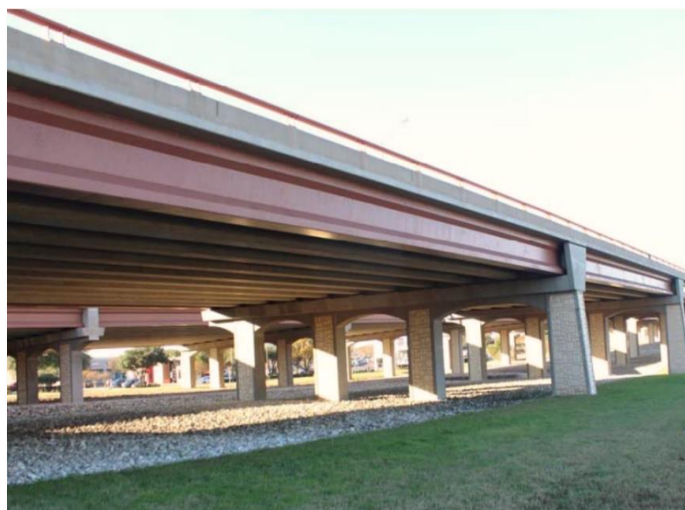
**Figure 11: SH 45N Bridge at Greenlawn Blvd**

TxDOT inspects all bridges within the CTTS biennially, with findings from the most recent inspection (FY 2020) indicating that 90.6% of the components were rated Good to Excellent. A total of 749 components in the categories used to evaluate bridge load ratings were inspected on the 238 structures within the CTTS. Only 70 components (9.4%) had a rating as low as 6 (Satisfactory), with the remainder of the ratings all in the 7 to 9 range (Good to Excellent). The

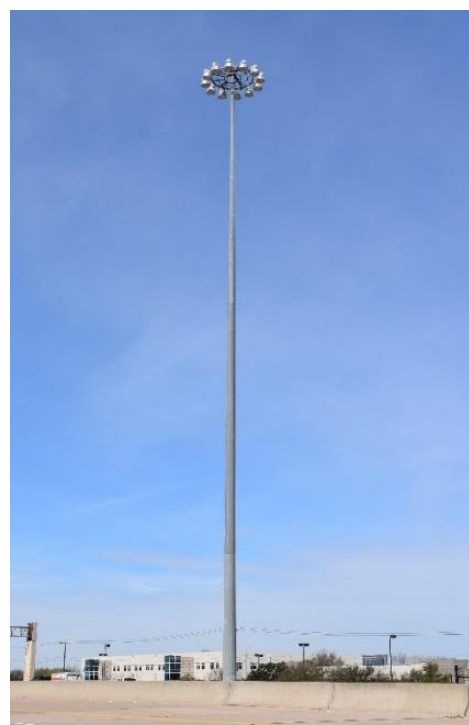
**Figure 13: High-Mast Light Tower**

Beginning in FY 2011, the HMLTs inspection occurred biennially with inspections being alternated on two roadways per year. During this year's inspection, SH 45N and SH 45SE were inspected, which consists of 90 structures. The results indicate that 99.5% of the 22,466 components were rated Satisfactory to Good which is a 0.1% improvement from the SH 45N and SH 45SE inspection that was conducted in FY 2019.
